Aviation Investigation Preliminary Report

Location:	Laredo, TX	Accident Number:	CEN26FA228
Date & Time:	June 16, 2026, 22:00 Local	Registration:	N523QS
Aircraft:	TEXTRON AVIATION INC 680A	Injuries:	1 Fatal, 1 Serious, 5 Minor
Flight Conducted Under:	Part 91 subpart k: Fractional

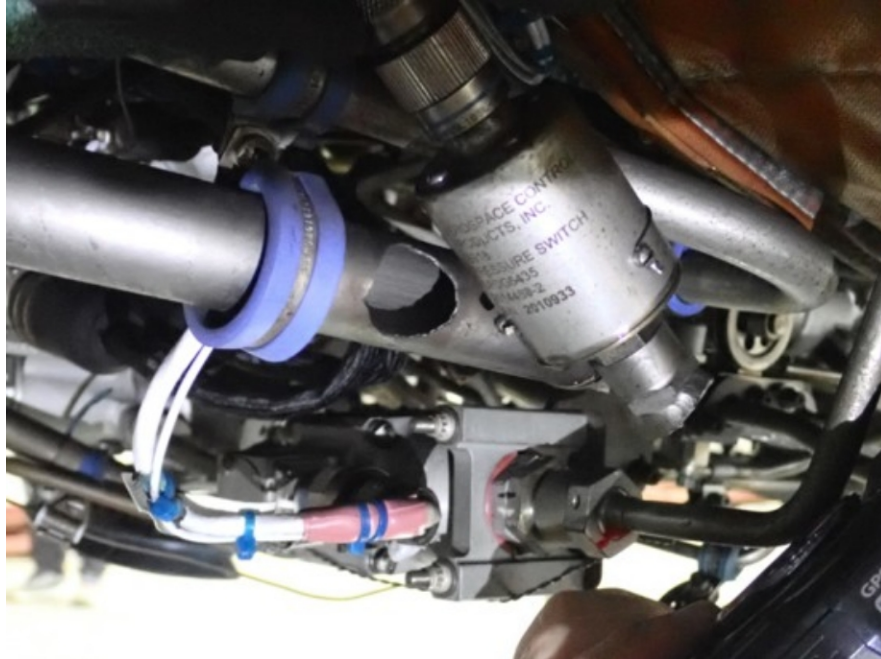
The airplane wreckage was initially recovered to a secure hangar at LRD for preliminary examination. During the examination, flight control continuity was established for the ailerons, elevator, and rudder. Further examination revealed that the right engine fuel pressure switch (part number 9914488-2) was found separated from the fuel tube assembly (part number 6956100-118) and the fuel tube assembly was fractured adjacent to the weld joint for the attachment tube leading to the fuel pressure switch as shown in Figure 1. Multiple P-clamps on the fuel tube assembly were also found fractured as shown in Figure 2.

Figure 1. Right engine fuel tube assembly and fuel pressure switch

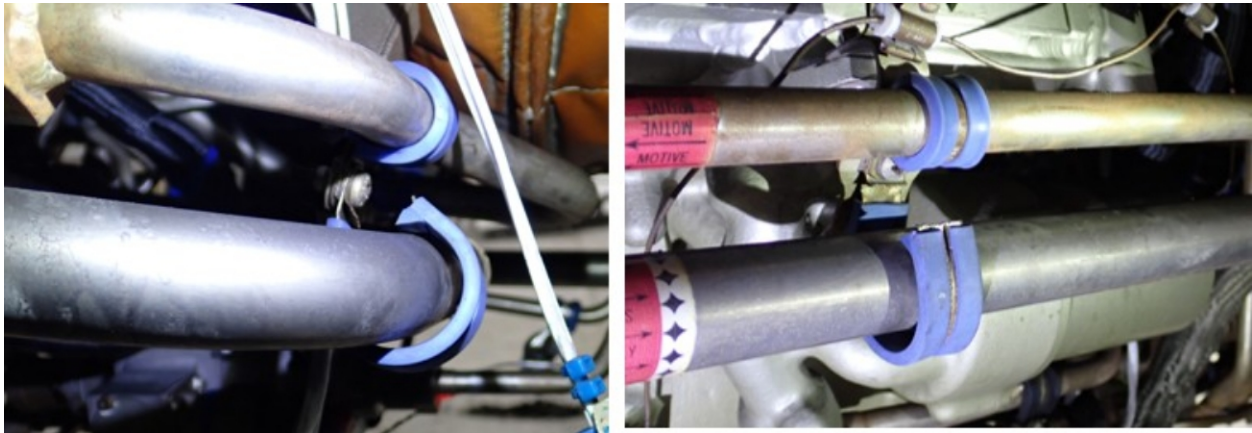
Figure 2. Fractured fuel tube assembly P-clamps

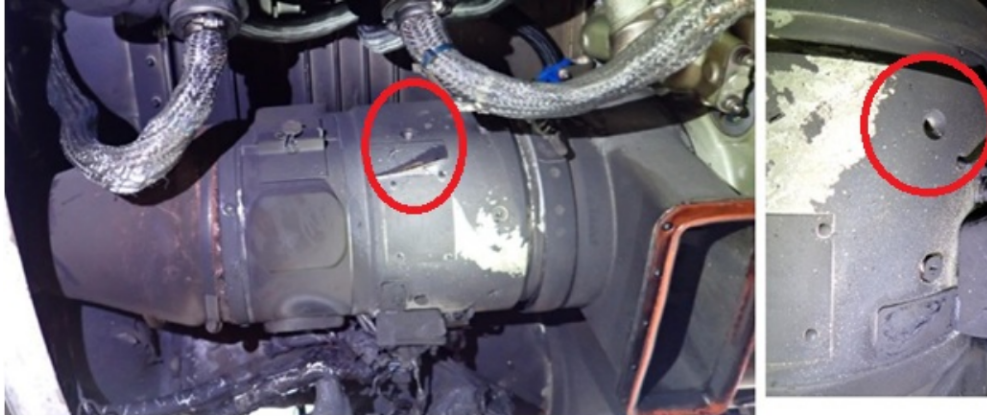
The right engine starter generator (part number 9914685-1; model number 23291-005; serial number P3825) was manufactured by Safran in October 2023. The starter generator was missing multiple screws from the outer housing as shown in Figure 3. The starter generator had 57.2 hours of time remaining since its last overhaul that was performed on April 25, 2025; the overhaul interval was 1,200 hours.

Figure 3. Right engine starter generator and missing screws (red circles)

Upon removal of the starter generator, the starter generator shaft was found bent, the cooling fan was fractured, and multiple cooling fan blades and ball bearings were found when the generator was removed. The cooling fan shroud also contained circumferential scoring marks.
